FINAL SITE INVESTIGATION REPORT

TOGIAK HEALTH CENTER
TOGIAK, ALASKA

ANTHC Project No. AN-06-G16

December 2007

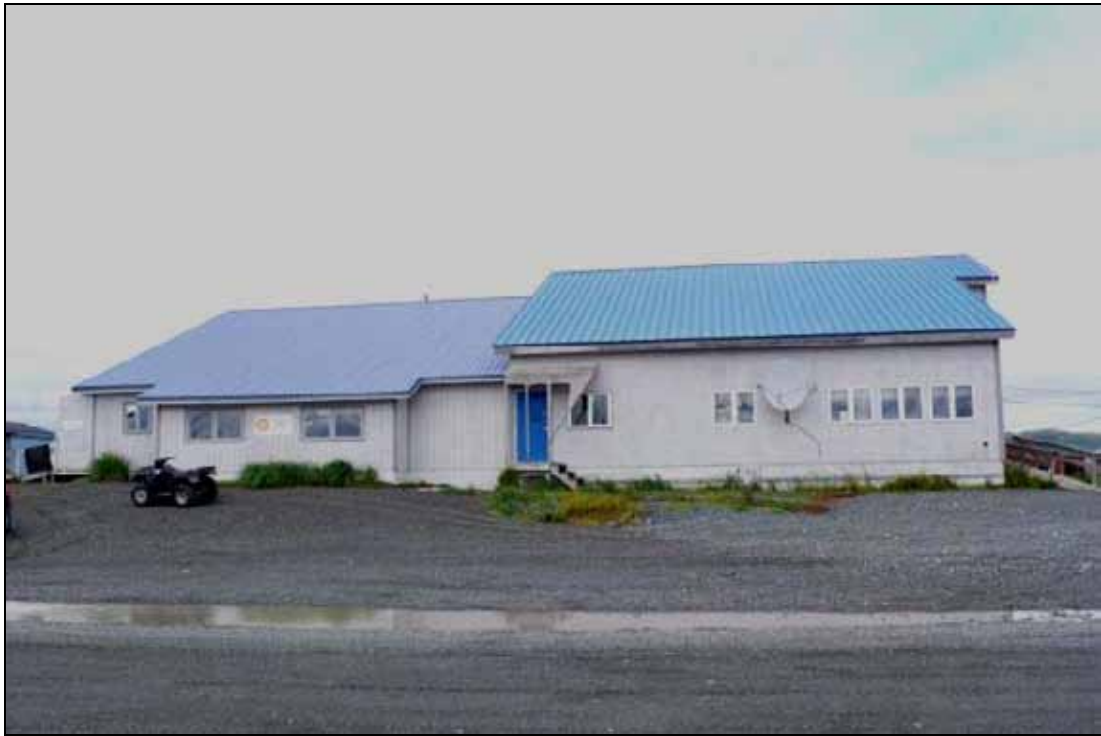
Photograph 1: Existing Clinic, Exterior, Front Building Face

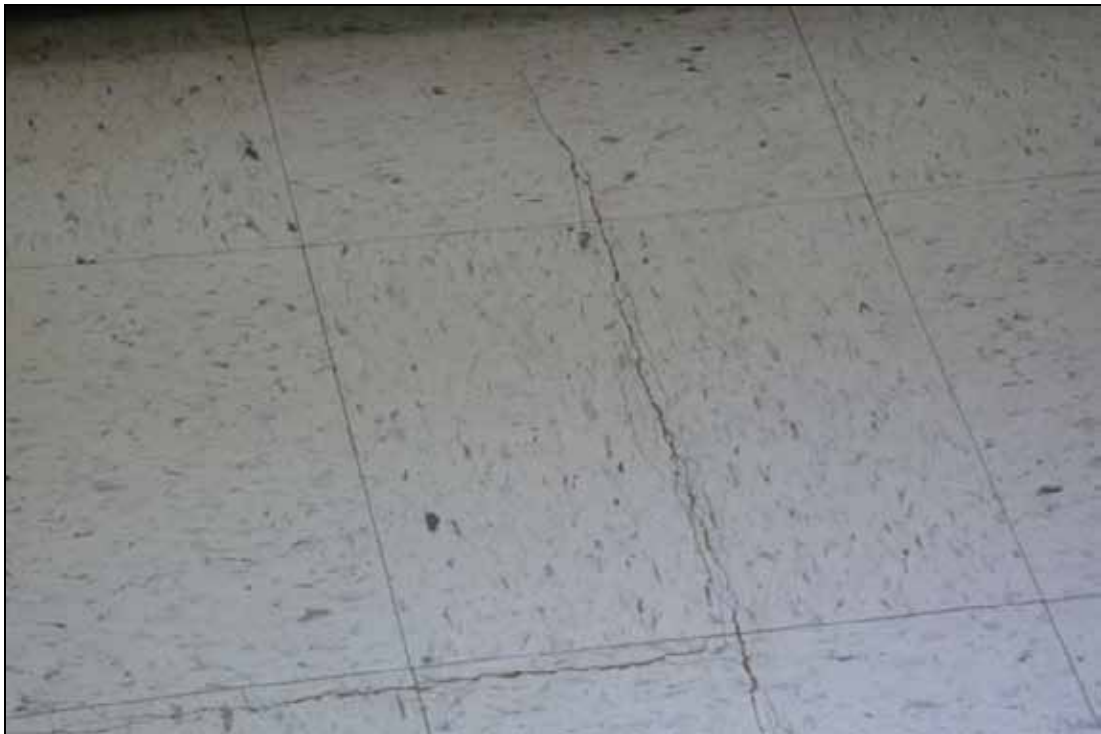
Photograph 6: Existing Clinic, Interior Floor Cracking

There is not sufficient space at the current clinic to meet the needs of the community. The current clinic also does not meet current codes and standards for clinics, such as the previously mentioned lack of egress route. Though a code and condition survey was done as part of this report, several other code issues are noted in the Section II, Draft Space Program. The clinic would require an expansion of almost double the existing space to meet the needs of the community. The existing portions of the clinic would also need renovation to come into code compliance.

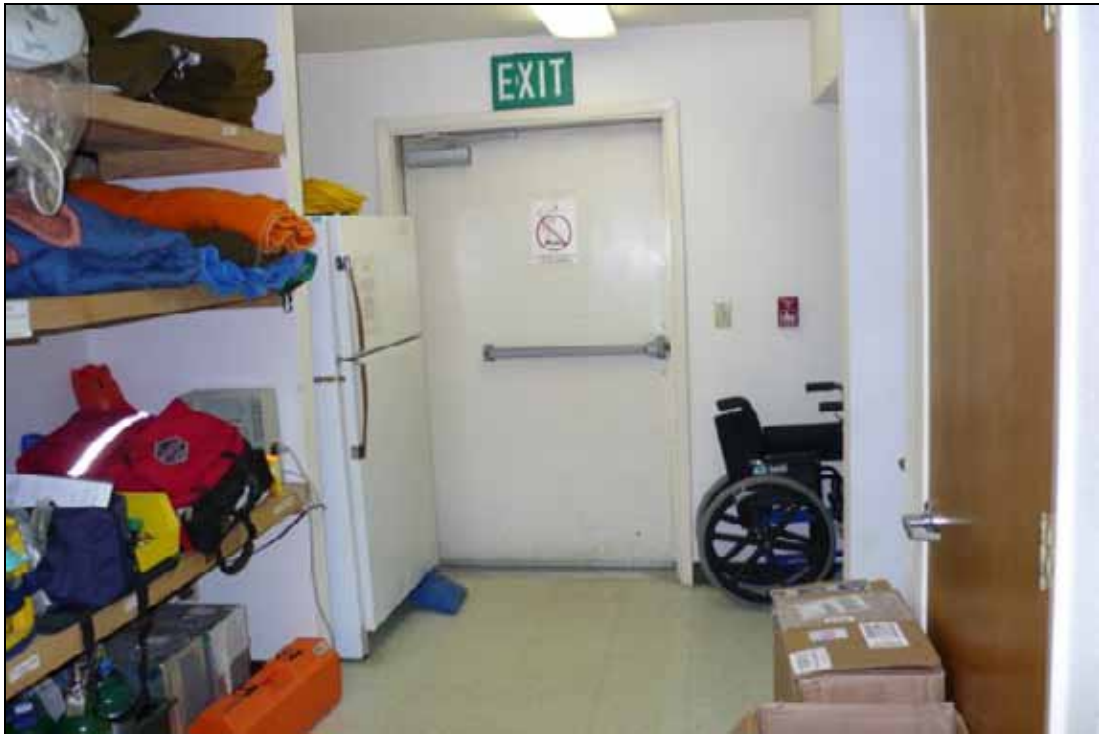
Photograph 7: Existing Clinic, Interior, Storage and Emergency Exit

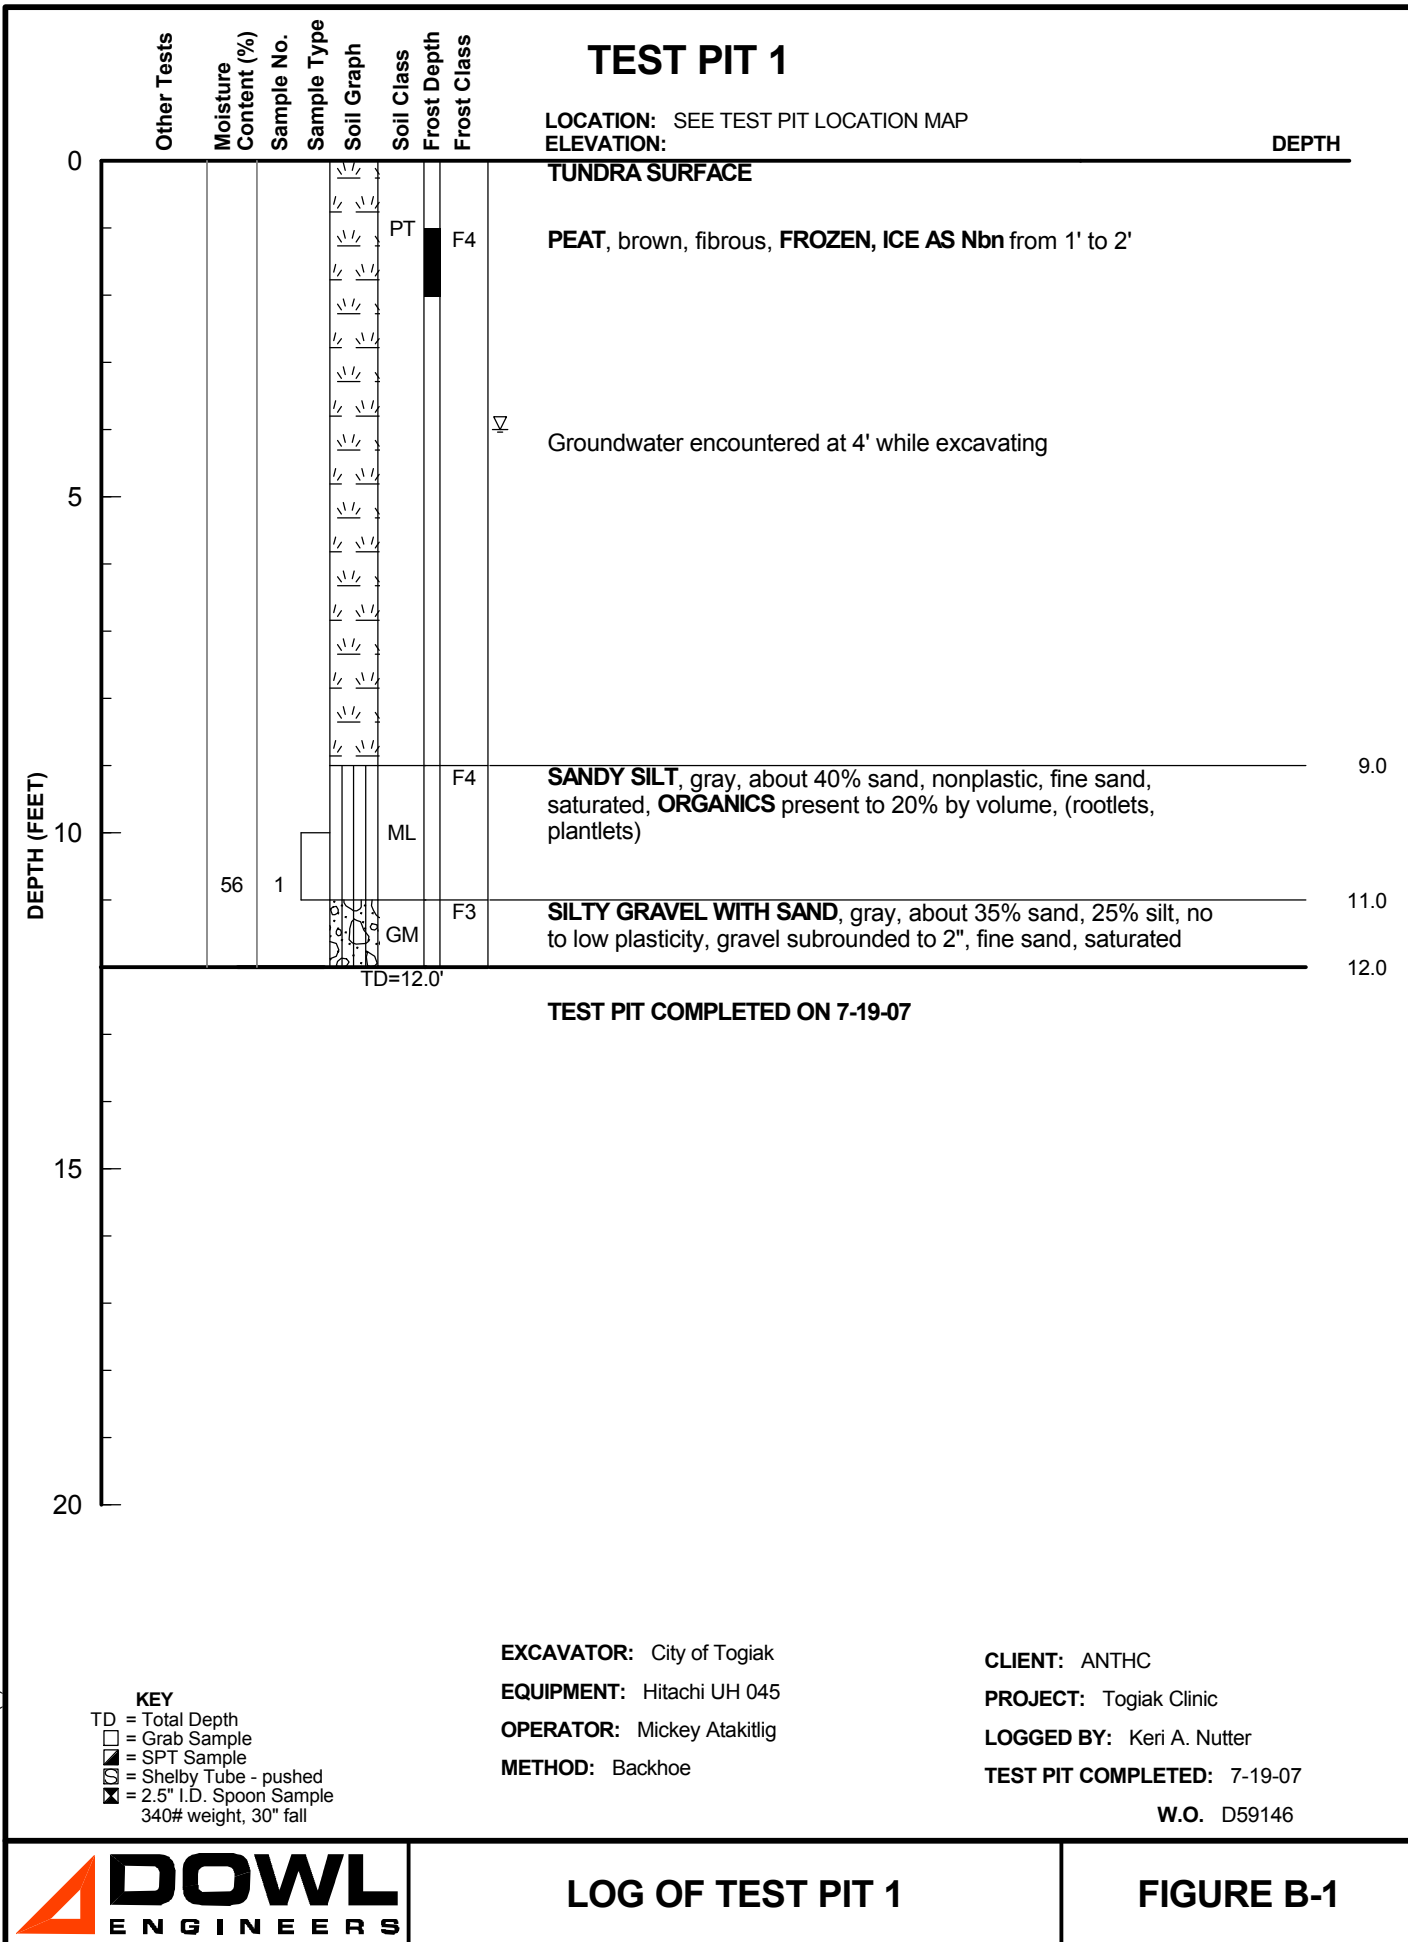
TEST PIT 2

Subsurface. The subsurface soils across the site are generally consistent. Peat (PT) was observed in each of the test pits to depths ranging from four to ten feet, with deeper peat at the southern end of the site. Below the peat (PT), sandy silts (ML) and silty sands and gravels (SM, GM) were observed.

The native silts (ML) have varying amounts of sand and exhibit no to low plasticity. The silts are highly frost susceptible (F4). In Test Pit 5, a six inch layer of lean clay (CL) was observed at a depth of eight feet. The *in situ* moisture contents of the silts range from 49 to 56 percent.

Underlying the peat and silts, silty gravels with sand (GM) were encountered at depths ranging from 4 to 14 feet across the site and contain varying amounts of sand, silt, and clay. These soils have moderate to high frost susceptibility (F3-F4). The *in situ* moisture content ranges from 10 to 16 percent.

Groundwater. Groundwater was observed in four of the test pits while excavating at depths of three to eight feet and was not observed while excavating the remaining test pits. It appears that deeper groundwater is at the southern end of the site.
